# Special Report 81-10

May 1981

## FABRIC INSTALLATION TO MINIMIZE REFLECTION CRACKING ON TAXIWAYS AT THULE AIRBASE, GREENLAND

Robert A. Eaton and Randy Godfrey

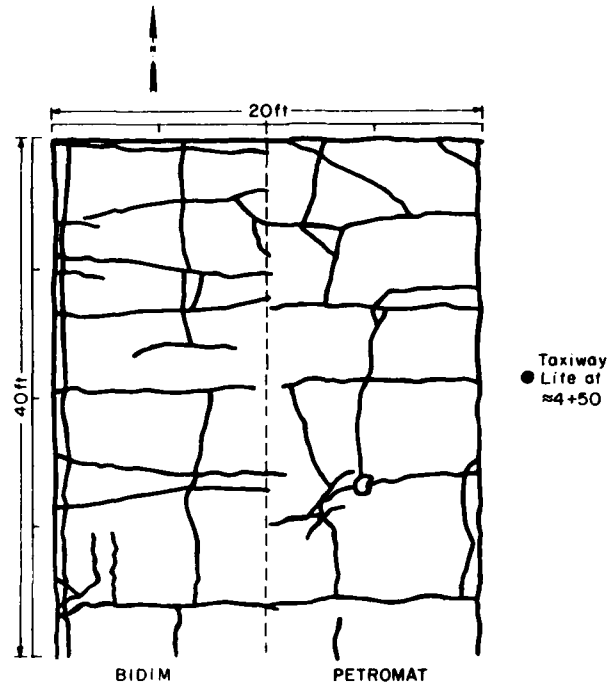
Figure 6. Preconstruction cracks in taxiway 3 (June 1978).

During the crack filling operation, we saw that there were approximately four times as many cracks on the PETROMAT side (east) as on the BIDIM (west) side of taxiway 3. The cracks in the entire fabric area were remapped as they were significantly different than the premilling cracks which had been mapped four weeks before (Fig. 6-9).

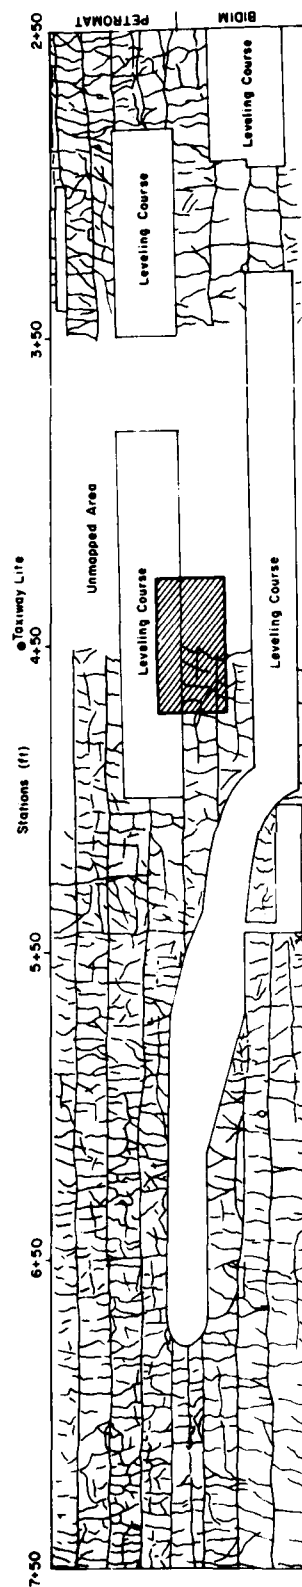
Figure 7. Map of cracks in taxiway 3 after milling (August 1978) (shaded area shown in Fig. 9).

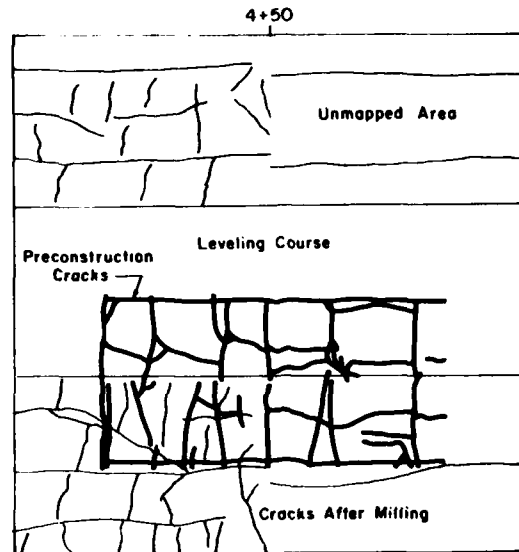
Figure 9. Preconstruction cracks in taxiway 3 (June 1978) overlaid on cracks left after milling (August 1978).
